Research report

Abrasion resistance testing of CovidSafe

basic membrane

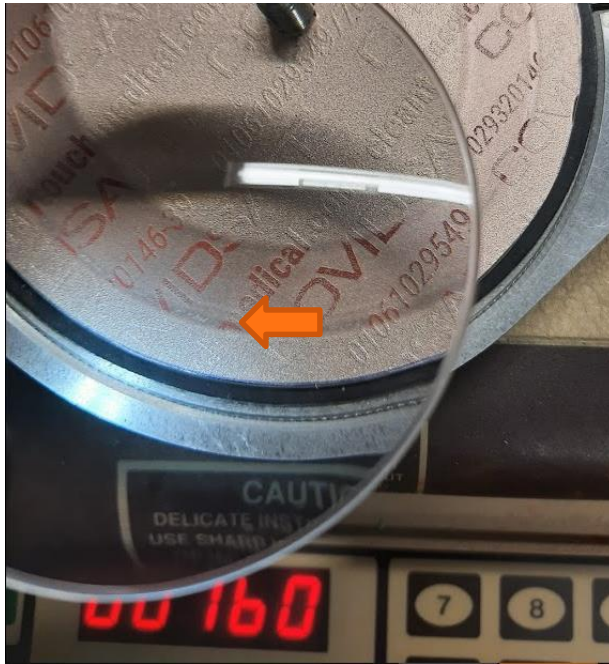
The first test piece shows traces of puncture-abrasion after 160 revolutions. In this case, the metal surface has worn away at the outer edge of the grinding wheel groove and the white base is visible (figure 1).

Figure 1. Test piece 1. Puncture-abrasion visible at 160 rpm.

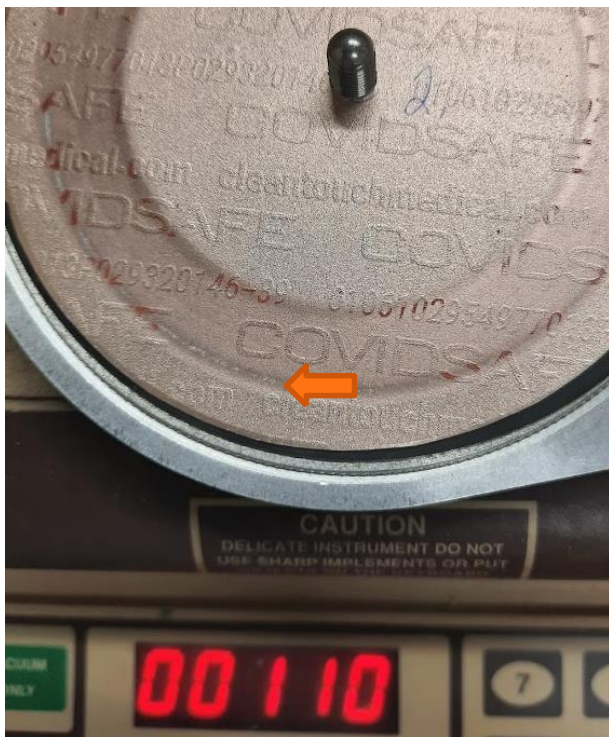
The second test piece shows traces of puncture-abrasion after 110 revolutions at the outer edge of the grinding wheel groove (figure 2).

Figure 2. Test piece 2. Puncture-abrasion visible at 110 rpm.

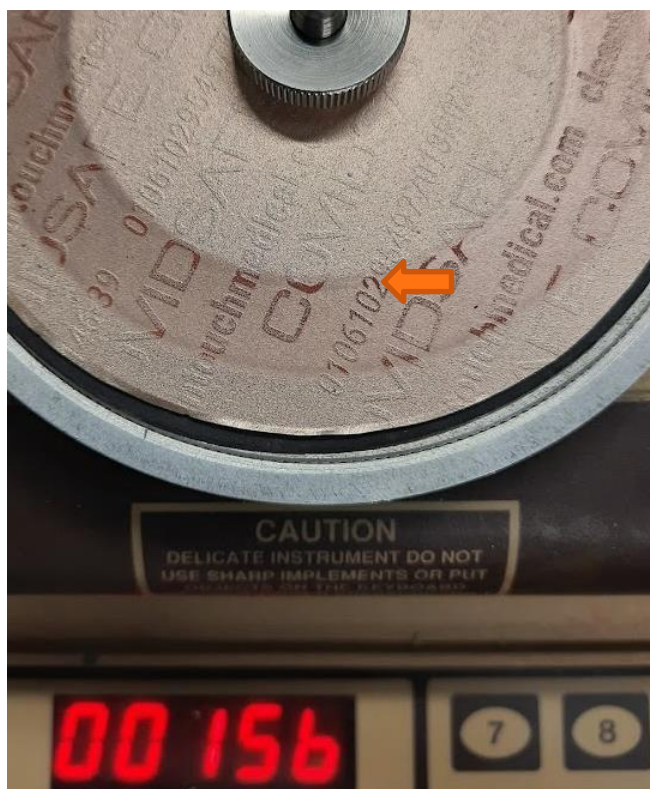
The third test piece shows traces of puncture-abrasion after 156 revolutions at the inner edge of the grinding wheel groove (figure 3).

Figure 3. Test piece 3. Puncture-abrasion visible at 156 rpm.
